**COMPLETION REPORT
BROWNFIELDS PROGRAM
NORTH VALLEY PUBLIC LIBRARY
208 MAIN STREET, STEVENSVILLE, MONTANA**

October 21, 2024

Project #: MDEQ0-024-0003

SUBMITTED BY: Trihydro Corporation

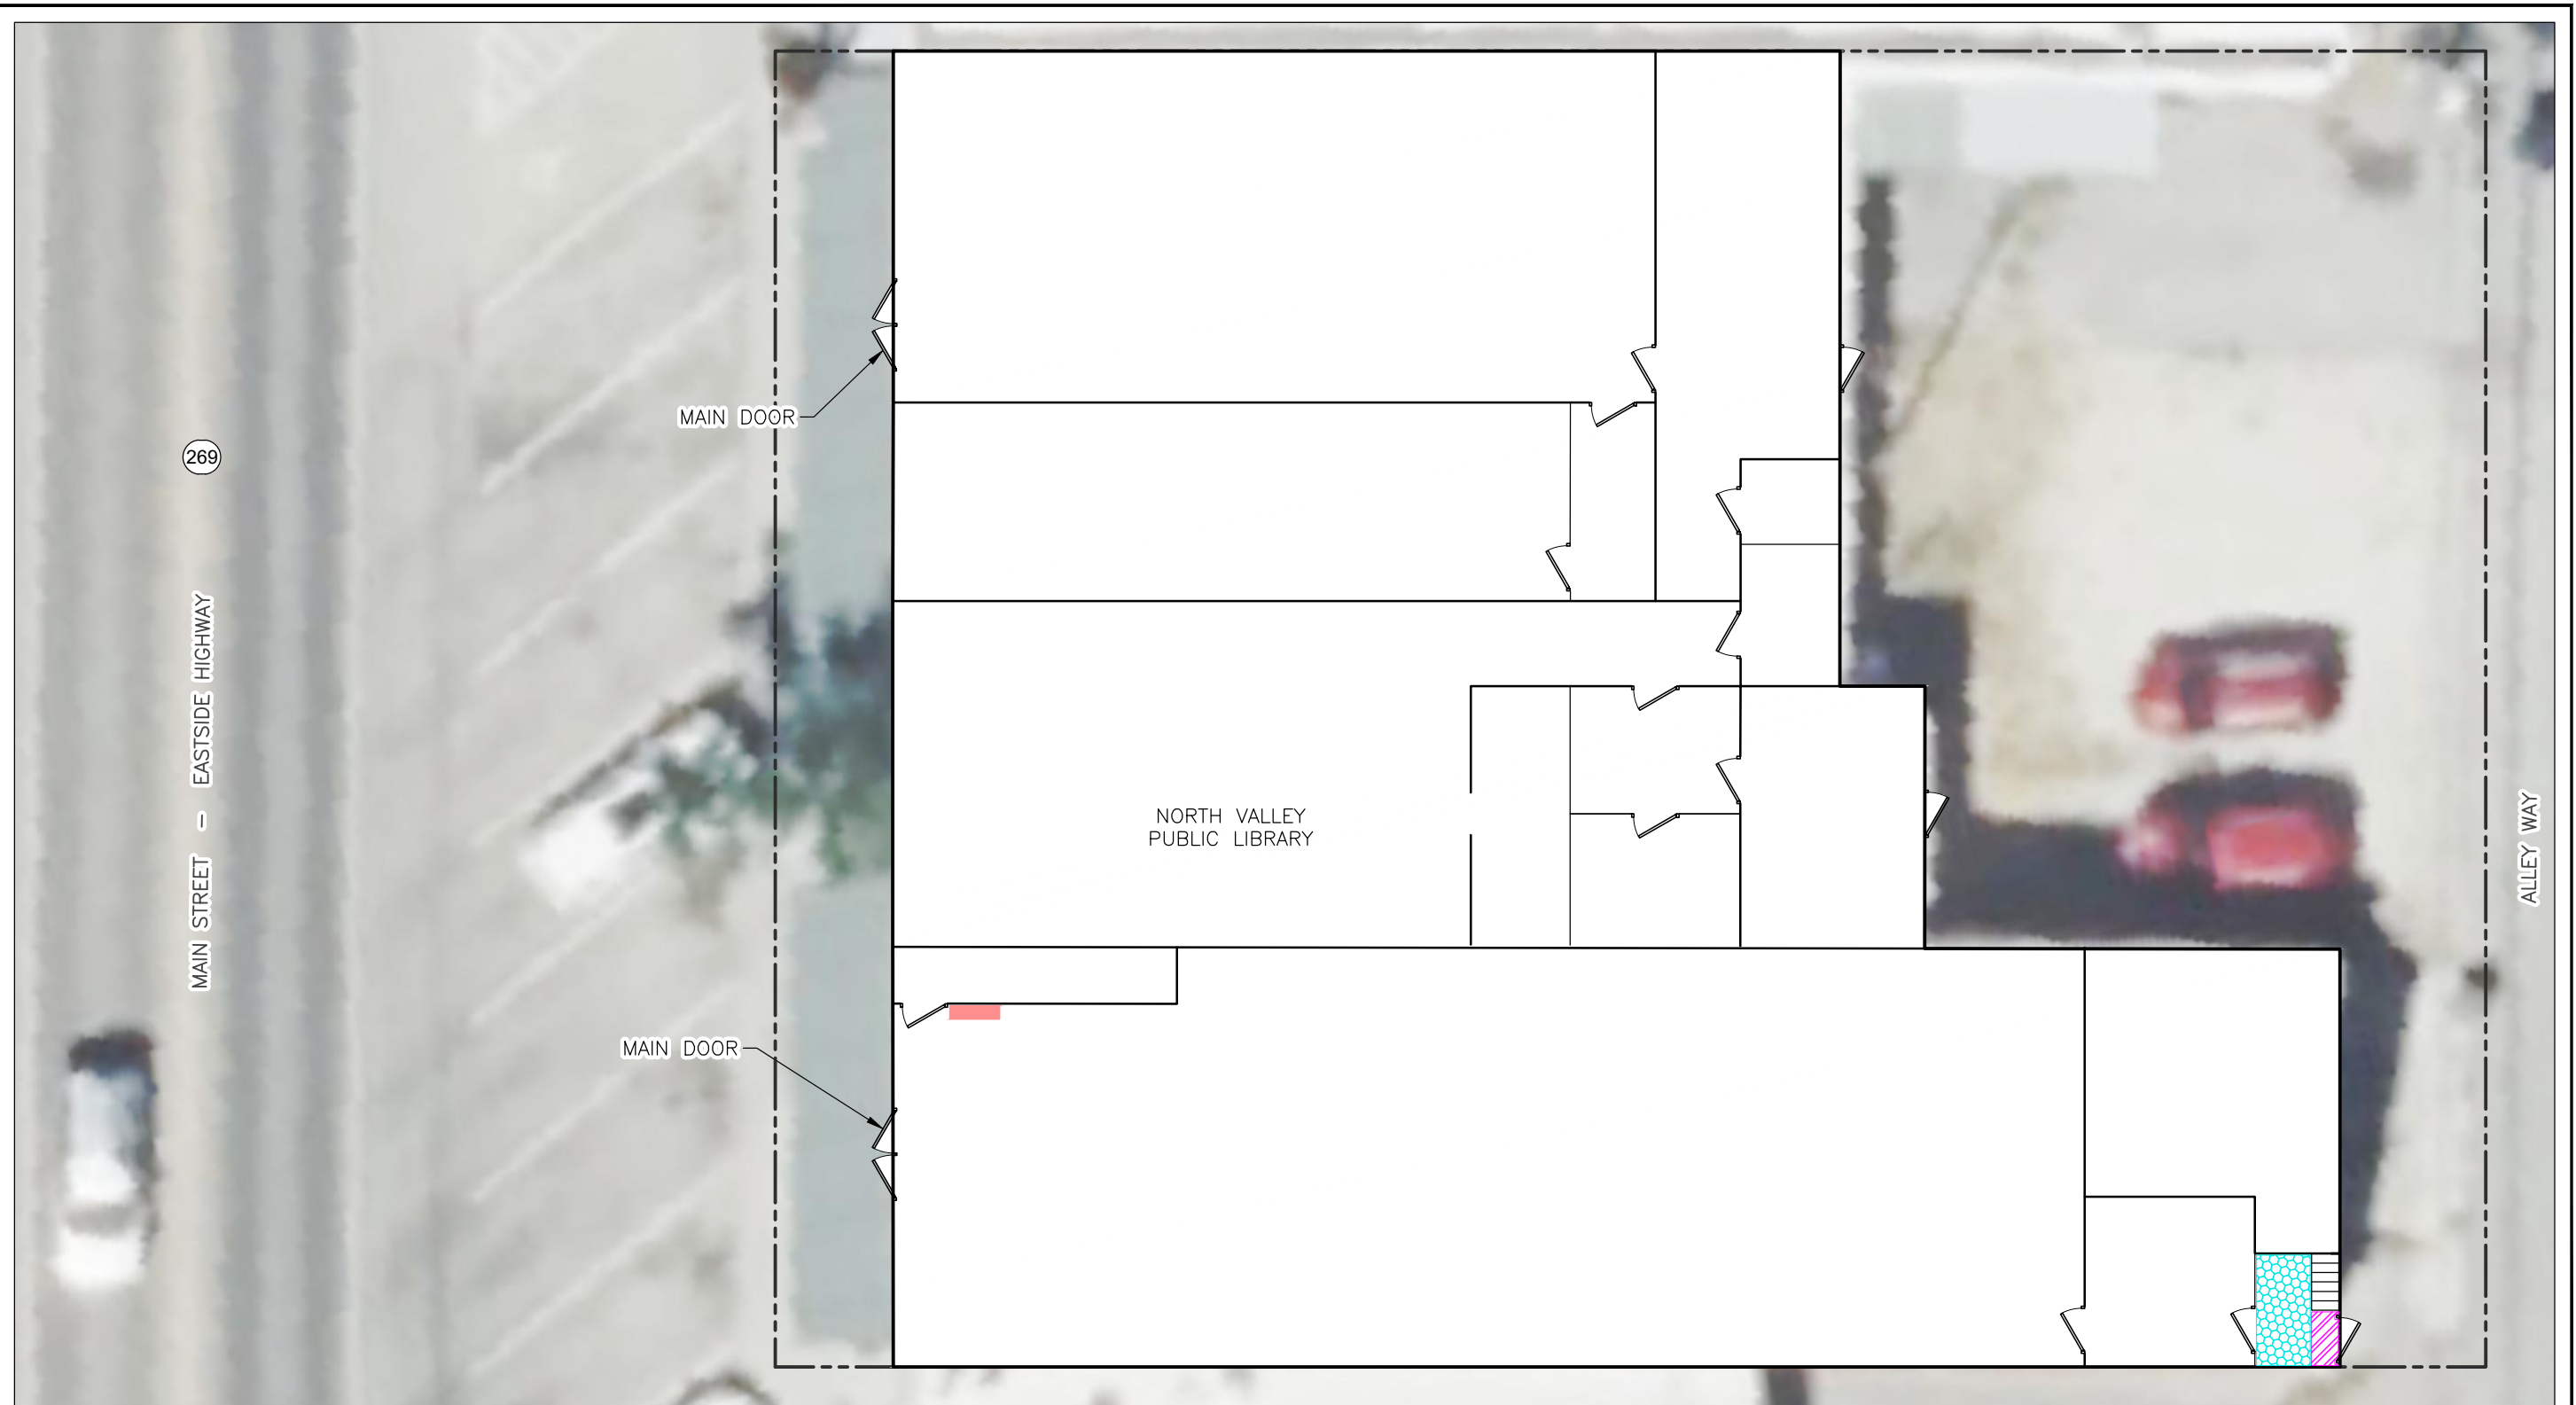
FIGURE 3
APPROXIMATE ACM AND LBP LOCATIONS
NORTH VALLEY PUBLIC LIBRARY
STREET LEVEL

- Worker air monitoring and personal protection equipment (PPE).
- Construction of temporary containment barrier and decontamination enclosures.
- Preparation for abatement operations including wet clean and/or high-efficiency particulate air (HEPA) vacuum.
- Abatement of damaged drywall (ACM) ceiling located in the street level (the drywall location is shown on Figure 3) and roofing (ACM) debris pile located in the upstairs storage room (the roofing location is shown on Figure 4).
- Encapsulate the wallpaper (ACM) located in the street level wall near the public printer/scanner (the wallpaper location is shown on Figure 3).
- Encapsulate the painted floor (LBP) located in the street level storage area / stairwell (the LBP floor is shown on Figure 3).

On July 29, 2024, approximately 1 ft² of damaged ACM ceiling drywall located on the street level southeast corner stairwell/storage room was abated and removed and approximately 15 ft² of spilled asphalt roofing material was abated and removed from the floor of the upstairs storage room. The stairwell, above the false ceiling, and the storage room were cleaned using a vacuum equipped with a high efficiency particulate air (HEPA) filter. Then surfaces were wiped down with damp, disposable cloths to remove remaining fugitive fibers, before the containment was disassembled. After removal, ACM debris was placed in sealed, labelled bags and transported offsite for disposal. Abatement of spilled and damaged ACM was completed on July 29, 2024.

On July 29, 2024, approximately 6 sq ft of white LBP wood flooring, located at the base of the southeast corner stairwell, was encapsulated using Fiberlock Lead Barrier Compound (LBC) white paint (Type III). Fiberlock LBC is an interior/exterior thermoplastic – elastomeric water based copolymer blend to form a barrier between LBP and the environment. The location of this LBP was a few feet away from the damaged ACM ceiling material. During the ACM spill abatement, the area with LBP was scraped to loosen and remove loose paint on the wooden flooring. As part of the ACM spill abatement all foreign matter was vacuumed up in the base of the stairwell/storage area using a vacuum with a HEPA filter; this included vacuuming the wood flooring covered with LBP. Three layers of Fiberlock LBC were applied over a period of multiple hours to the wooden flooring. Fiberlock Technologies, Inc., warrants Fiberlock LBC for a maximum of twenty years from the date the project is applied to form an effective barrier from the hazards of the encapsulated LBP as prescribed in Fiberlock’s project literature. The Fiberlock LBC project data sheet is provided in Appendix B.

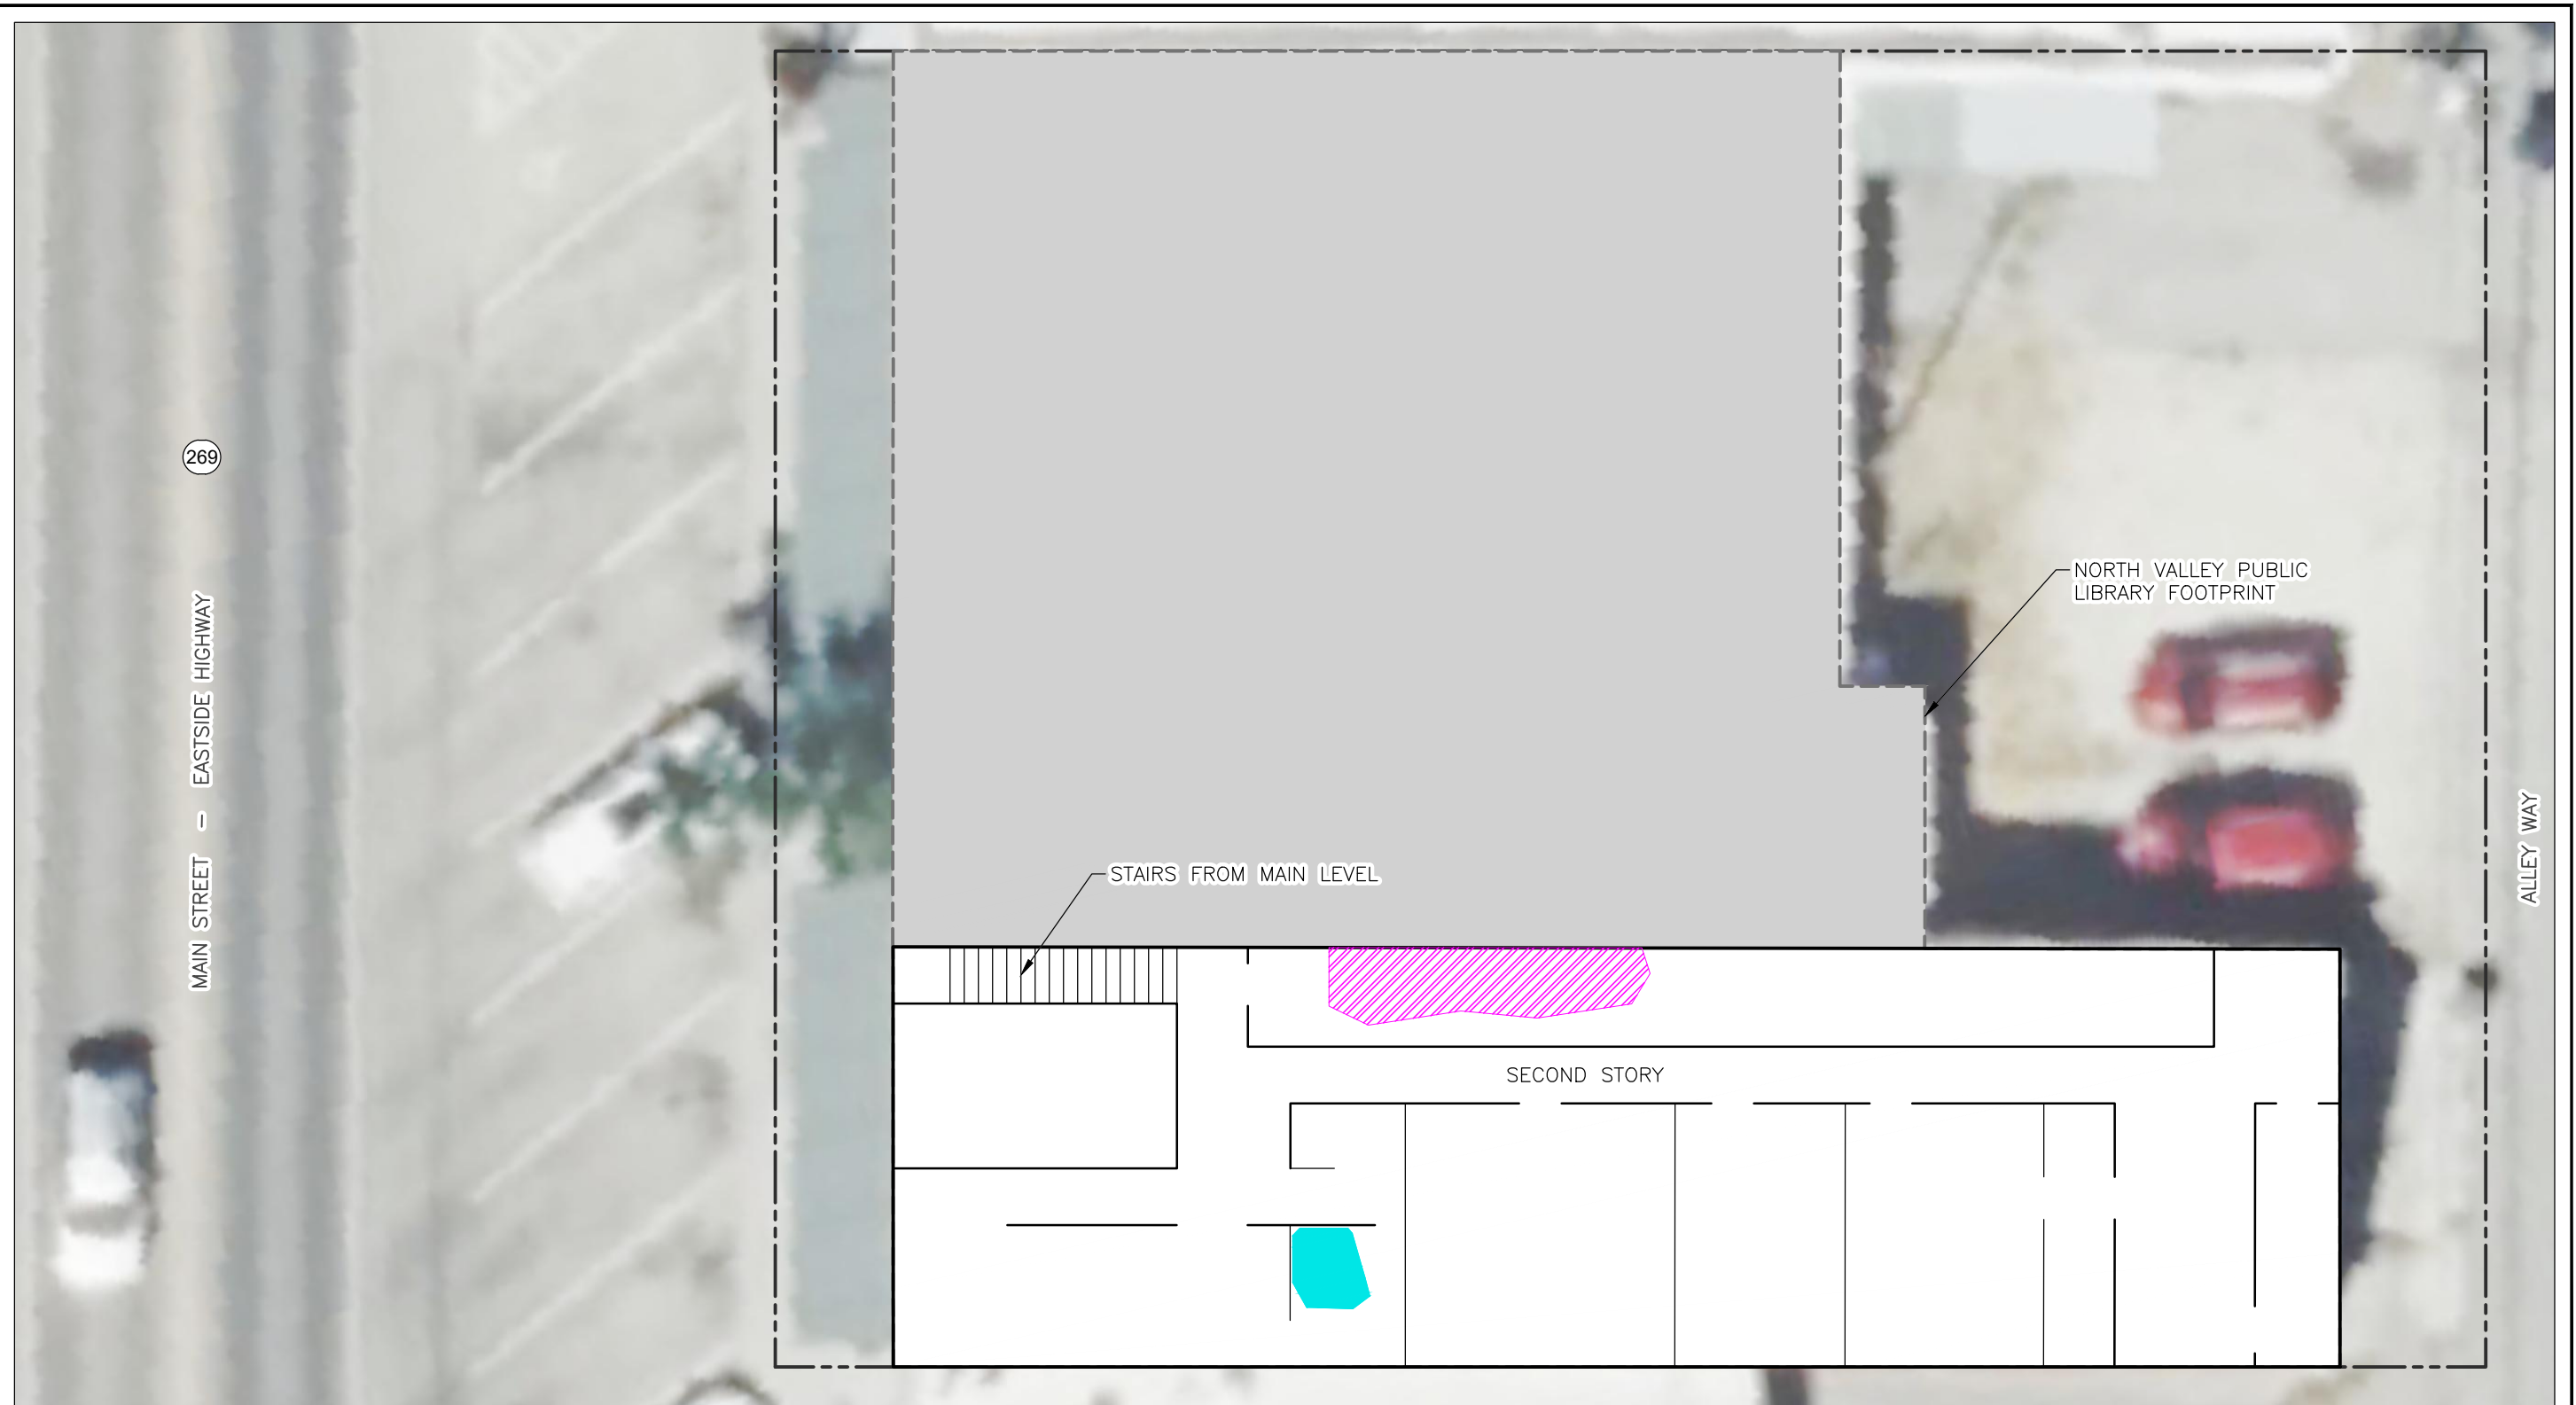
FIGURE 4
APPROXIMATE ACM AND LBP LOCATIONS
NORTH VALLEY PUBLIC LIBRARY
SECOND STORY

- Remove from the Site the door (LBP) and screen door (LBP) being stored upstairs (the location of the stored doors is shown on Figure 4).
- Transport and disposal of ACM and LBP to a Montana DEQ Solid Waste Management Section-permitted facility authorized to accept friable and non-friable ACM and LBP.

On July 29, 2024, the door and screen door that were being stored in the upper floor of the North Valley Public Library were wrapped in 6-mil plastic sheeting and removed from the property. The library had no plans to use the stored doors. Both the wooden door and wooden screen door were painted in yellow LBP and stored in the storage area next to the upper floor bathroom.

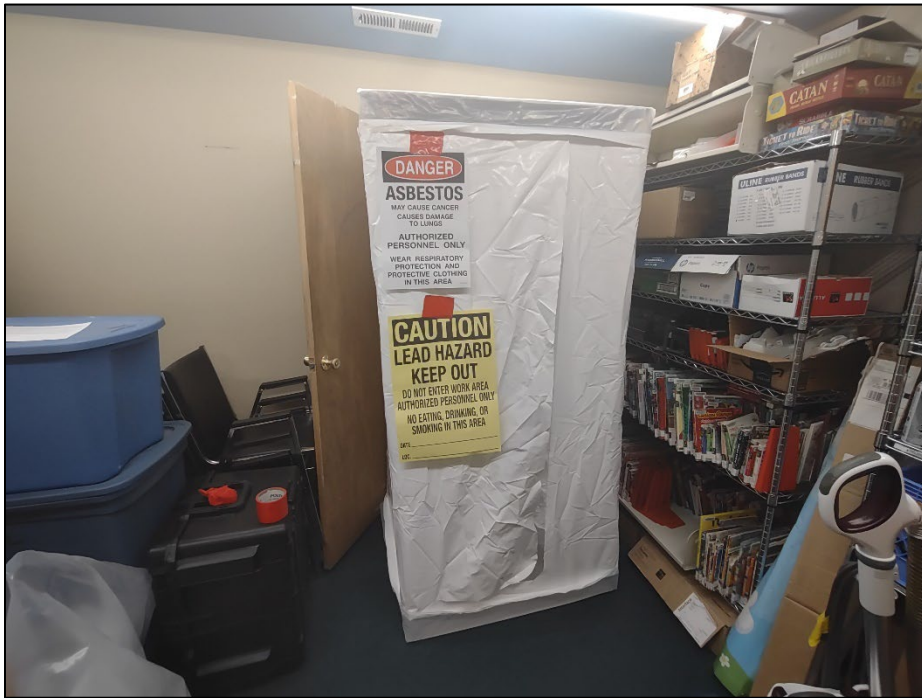
Photo 3. July 29, 2024. Main Floor: Containment installed outside of the office. The other side of the containment has the damaged drywall ceiling and LBP on the stairwell wooden floor.

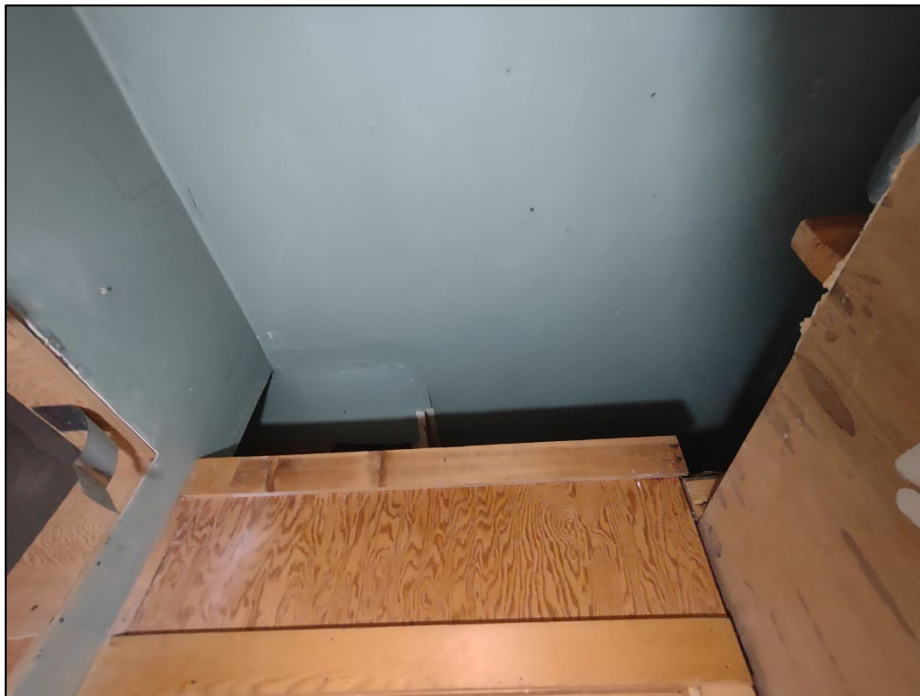
Photo 4. July 29, 2024. Damaged drywall ceiling: post cleanup of the spilled damaged ceiling drywall. The area was vacuumed (with HEPA filter) and wet wiped.

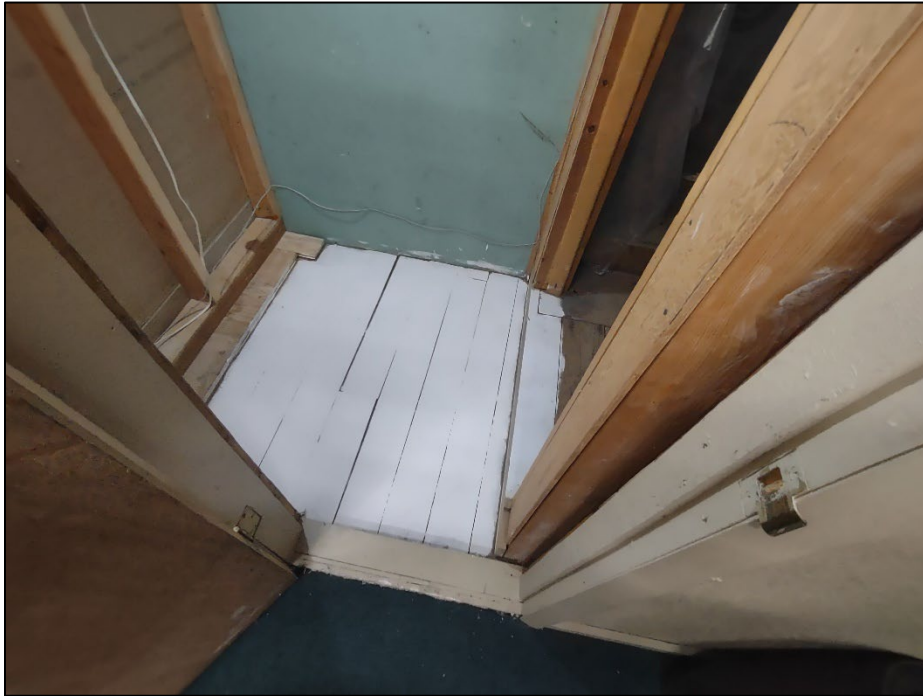
Photo 5. July 29, 2024. LBP Wooden Floor: The LBP covered floor was scraped and vacuumed to remove paint and debris before three coats of Fiberlock LBC were applied to encapsulate the LBP. The paint should be inspected six months after encapsulation and every year after.

The objective of the North Valley Public Library project was to reduce environmental hazards that library staff or the general public could come in contact with at the site. This included removing damaged ACM ceiling drywall and encapsulating LBP in the southeastern stairwell/storage room, encapsulating the wallpaper ACM next to the public scanner/printer, removing the spilled asphalt roofing material on the upper floor storage room, and removing the two stored doors covered with LBP in the upper floor. A final site walk with library staff was performed in the afternoon on July 29, 2024. A photolog documenting field activities is presented in Appendix E. Trihydro recommends an inspection performed by an EPA certified LBP Inspector of the two encapsulated barriers (Fiberlock LBC on the floor of the stairwell/storage room and the wood paneling encapsulating the wallpaper near the general public scanner/printer at six months (February 2025) after encapsulation, then once a year, and whenever an occupant reports damage. The encapsulation inspection should include looking for an air gap on the wood paneling bonding to the plaster, and dirt, cracks, peeling, thin spots, dents, chemical damage, holes, sagging, and water damage on the encapsulated wood flooring.

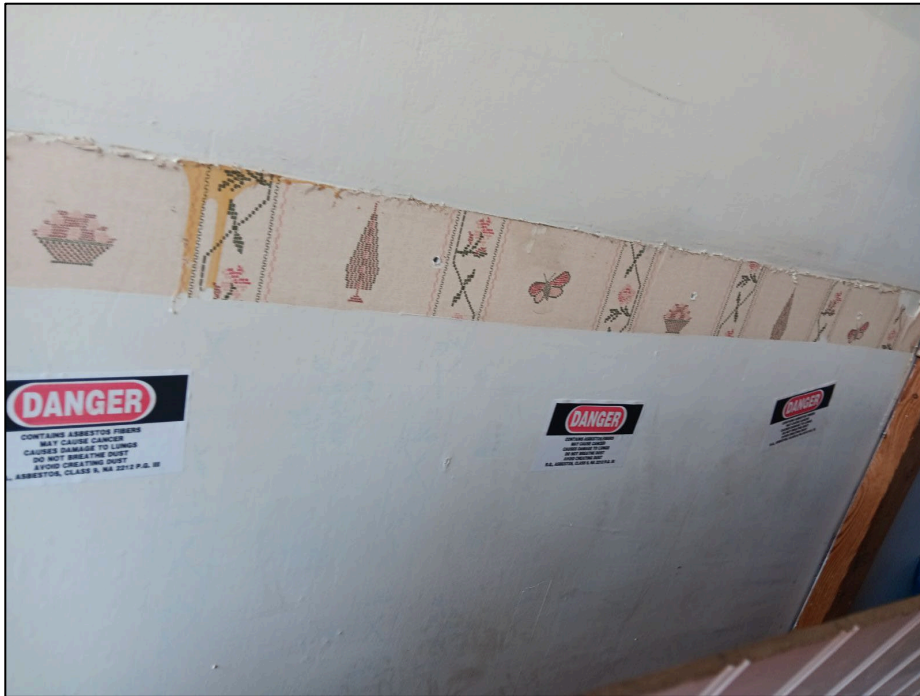
On July 29, 2024, approximately 4 linear feet of ACM wallpaper on top of plaster was encapsulated near the public scanner/printer. Danger signage was attached to the plaster near the wallpaper before wood paneling was installed over the warning signage, wallpaper, and lower section of the plaster wall. A sealant was installed to fill in the paneling edges to fully encapsulate the wallpaper. The encapsulation of the wallpaper with wood paneling protects the library staff and general public from disturbing the material.

Photo 6. July 29, 2024. Wallpaper Main Level: Warning signage attached to plaster near the wallpaper containing ACM.

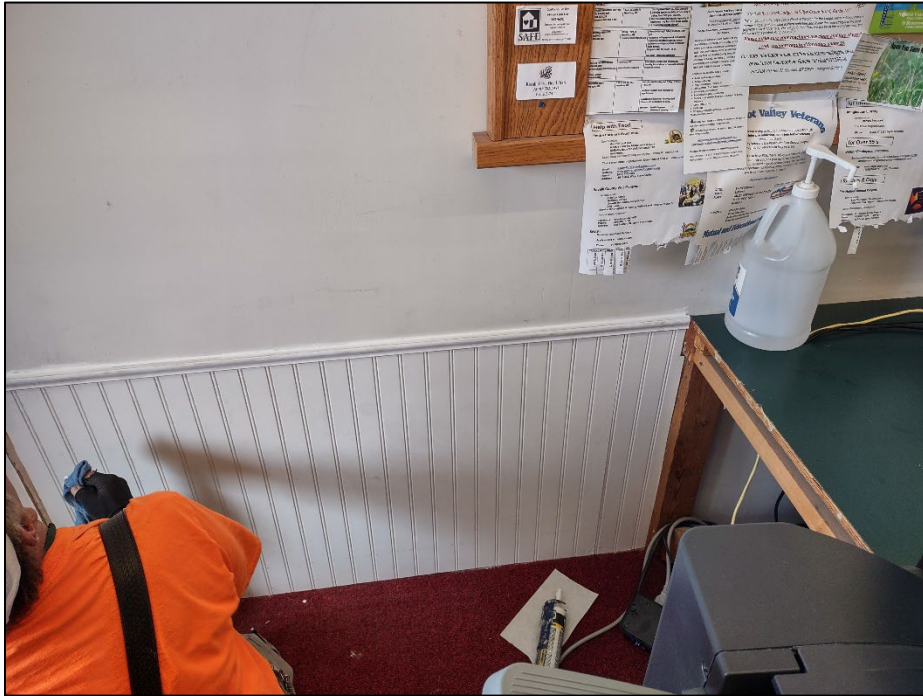
Photo 7. July 29, 2024. Wallpaper Encapsulation. Wood paneling covering the wallpaper and danger signage. The paneling edges were siliconed to prevent air gaps in the encapsulation. The paneling should be inspected six months after encapsulation and every year after.

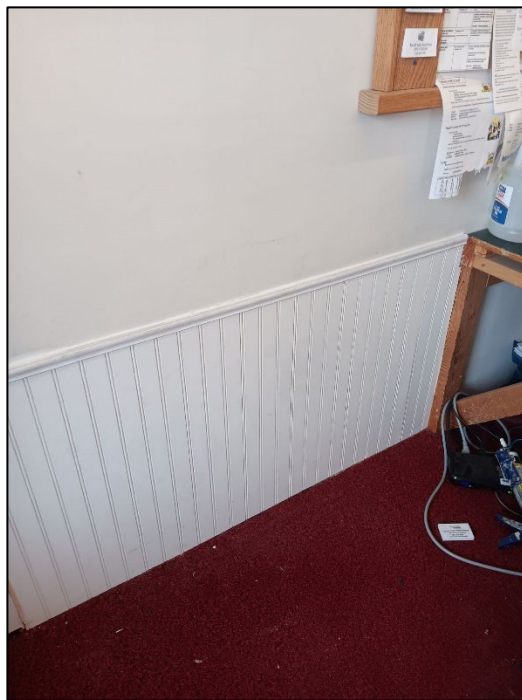
Photo 8. July 29, 2024. Wallpaper Encapsulation. The paneling should be inspected six months after encapsulation and every year after.

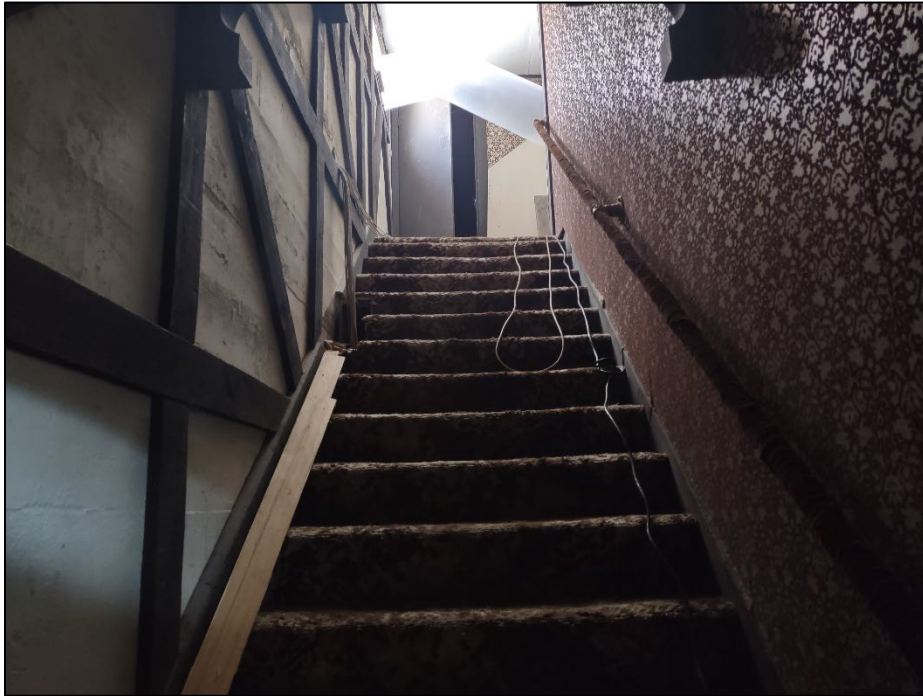
HDPE sheeting was also used to isolate the removal of spilled ACM in the upstairs storage room. HDPE sheeting was installed at the doorway to the storage room entrance / top of the stairwell. Additionally negative air was installed with filtered air discharged out the second story window using ducting.

Photo 9. July 29, 2024. Upper Floor Roofing Spill. Containment was installed at the entrance to the storage room at the top of the stairwell. On the floor of the storage room is asphalt roofing mixed in with paper insulation. Negative air was installed with venting out of a HEPA filter discharged out a second story window.

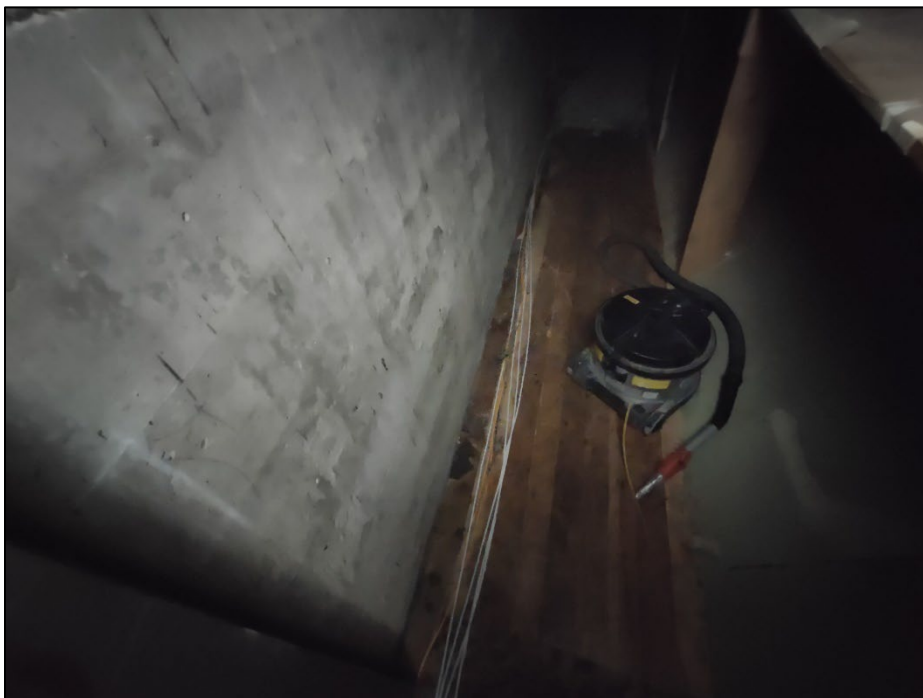
Photo 10. July 29, 2024. Upper Floor Roofing Spill. The storage room floor and surfaces were vacuumed (with HEPA filter) and wet wiped to remove the asphalt roofing material.
