**COMPLETION REPORT
BROWNFIELDS PROGRAM
NORTH VALLEY PUBLIC LIBRARY
208 MAIN STREET, STEVENSVILLE, MONTANA**

October 21, 2024

Project #: MDEQ0-024-0003

SUBMITTED BY: Trihydro Corporation

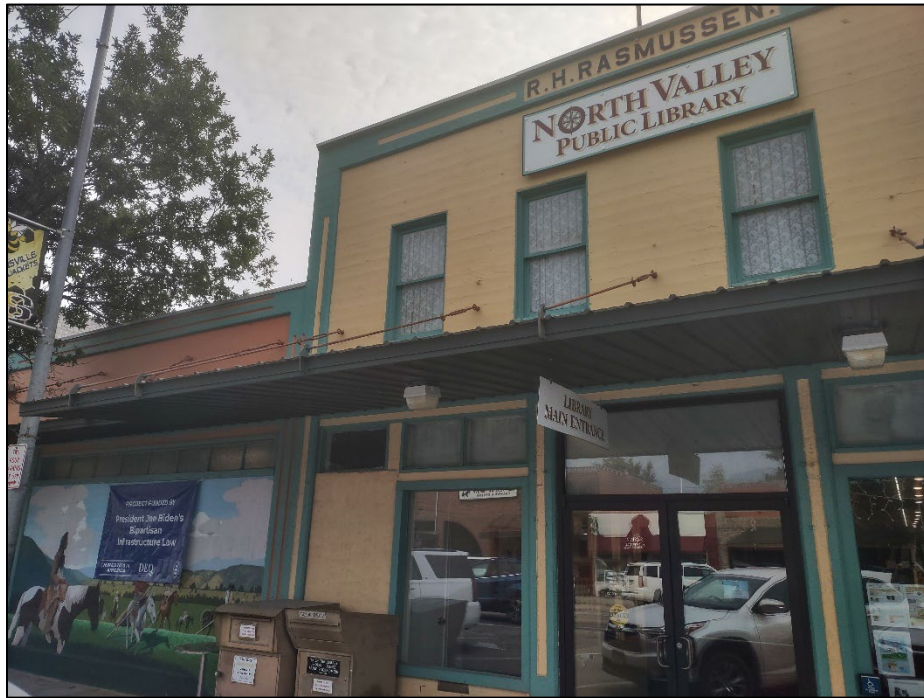
Photo 1. July 29, 2024. Outside looking northeast: Front entrance for the North Valley Public Library, a combination of three buildings plus an addition on the alley side. The main entrance is located on the yellow two-story building. The orange and red painted building is part of the library. The building's age ranges from 1910 and 1940; a remodel with an addition was performed in 1960.

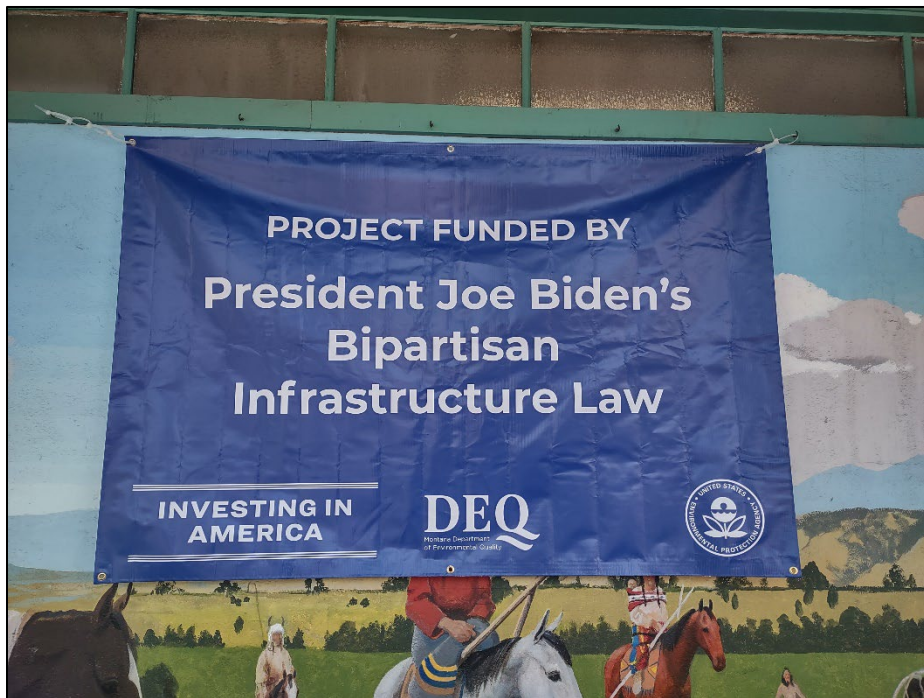
Photo 2. July 29, 2024. BILs Act Signage: Signage hung on the exterior of the library during abatement / encapsulation activities.
